Intel[®] 815E Chipset Platform for Use with Universal Socket 370

Design Guide Update

October 2002

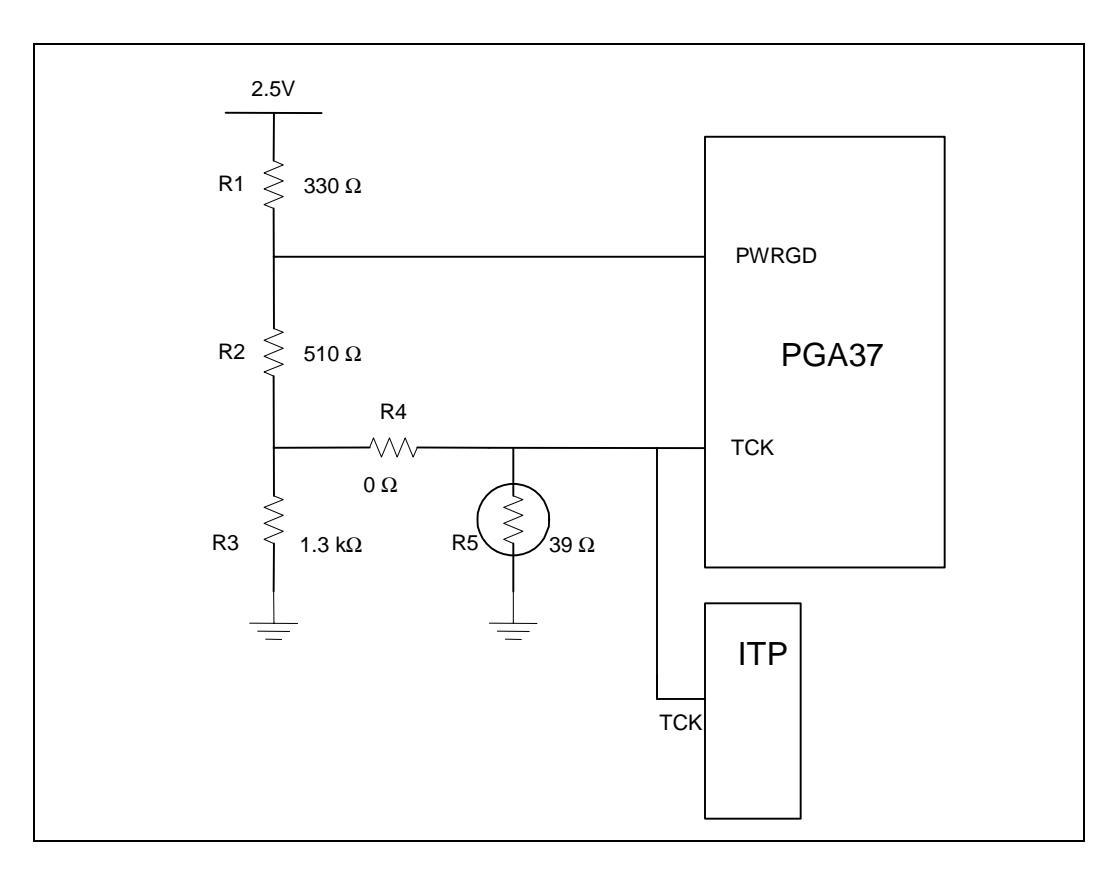
A platform supporting the 0.13 micron technology processor must implement a workaround required for the A-1 stepping of that processor, identified by CPUID = 6B1h.

The internal control register bit responsible for operation of the THERMTRIP circuit functionality may power up in an un-initialized state. As a result, THERMTRIP# may be incorrectly asserted during de-assertion of RESET# at nominal operating temperatures. When THERMTRIP# is asserted as a result of this, the processor may shut down internally and stop execution. In addition, when the THERMTRIP# pin is asserted the processor may incorrectly continue to execute, leading to intermittent system power-on boot failures. The occurrence and repeatability of failures is system dependent, however all systems and processors are susceptible to failure.

To prevent the risk of power-on boot failures, a platform workaround is required. The system must provide a rising edge on the TCK signal during the power-on sequence that meets all of the following requirements:

- •Rising edge occurs after Vcc_core is valid and stable
- •Rising edge occurs before or at the de-assertion of RESET#
- •Rising edge occurs after all Vref input signals are at valid voltage levels
- •TCK input meets the Vih min (1.3 V) and max (1.65 V) spec requirements

For Production Boards: Depopulate R5

To use ITP: Install R5, Depopulate R4

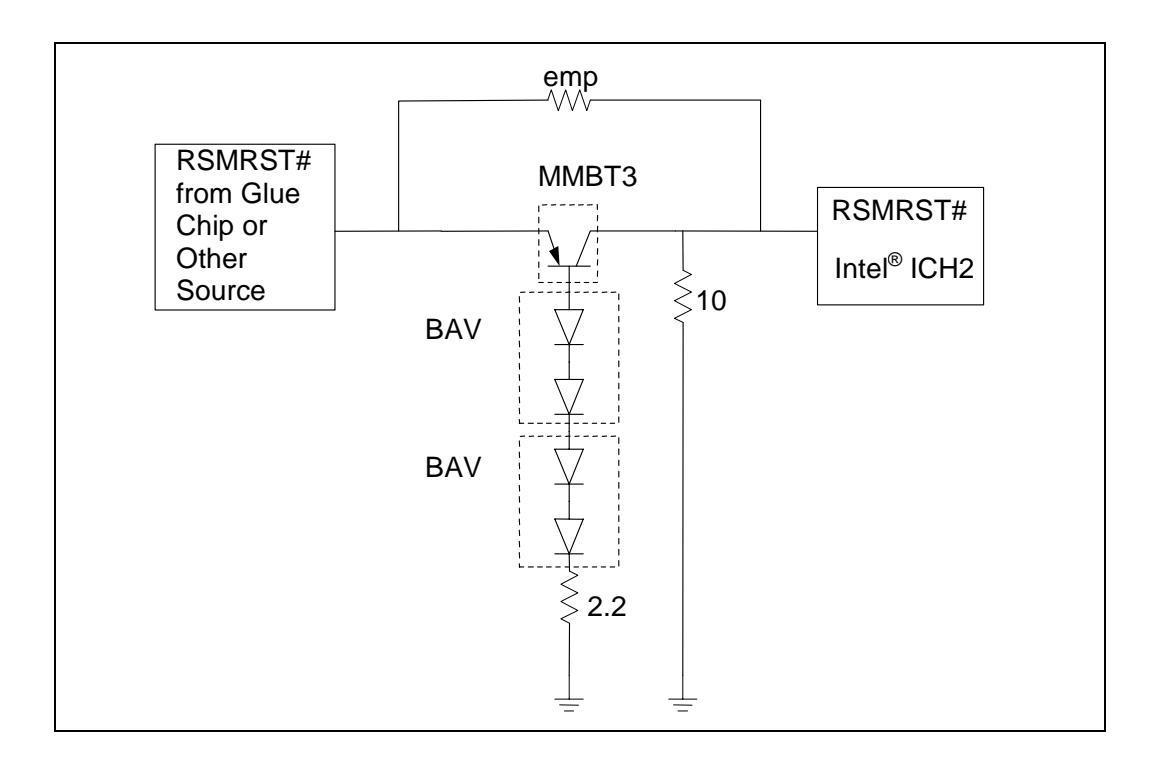
The circuit shown in the figure below should be implemented to control well isolation between the 3.3 V resume and RTC power-wells. Failure to implement this circuit may result in excessive droop on the VCCRTC node during Sx-to-G3 power state transitions (removal of AC power).

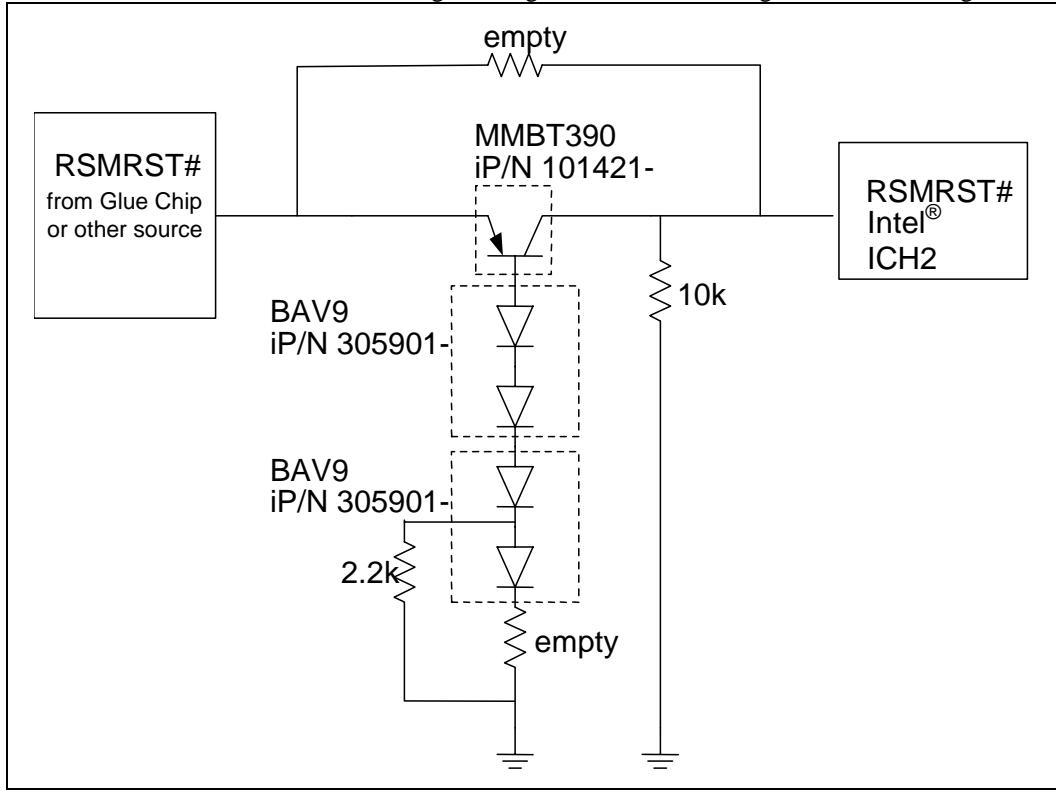
14. Changed Figure 81-a, *RTC Power Well Isolation Control*, in Section 11.8.6, *Power Well Isolation Control Strap Requirements*

Figure 81-a, *RTC Power Well Isolation Control*, was added in the *Intel*[®] 815E Chipset Platform for Use with Universal Socket 370 Design Guide Update, dated October 12 2001, Document Number 298309-001, as document change #5. Figure 81-a is now changed to the following:

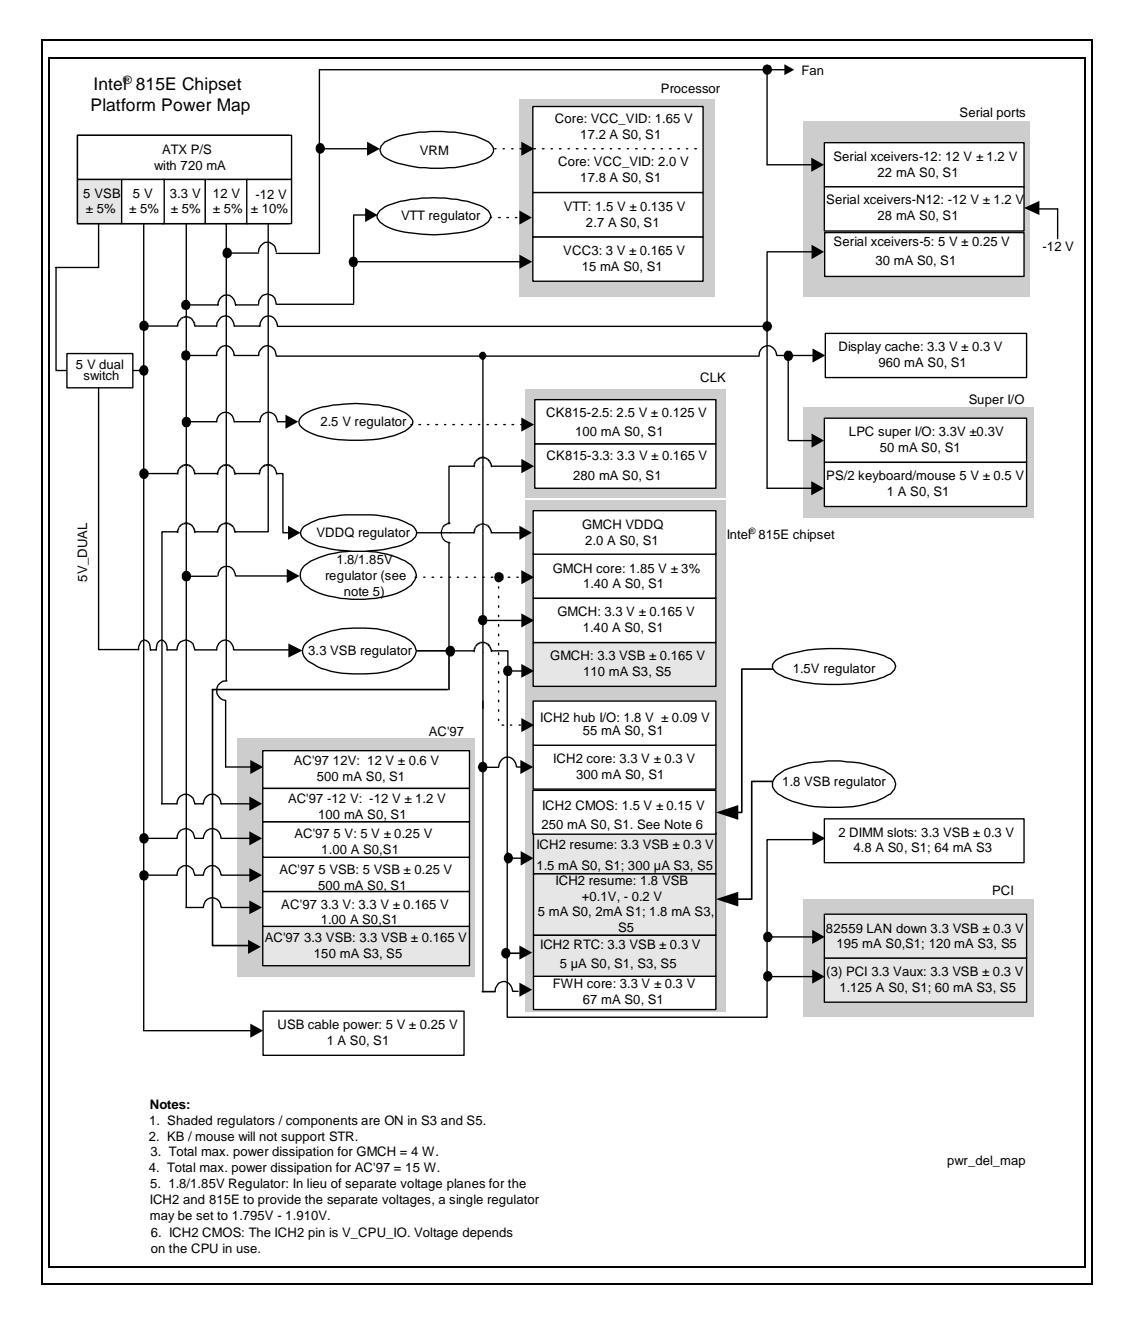
18. Changed Figure 100, Power Delivery Map, in Section 13, Power Delivery

Figure 100, *Power Delivery Map*, in Section 13, *Power Delivery*, was replaced by Document Change #8 in the public *Intel*[®] 815E Chipset Platform Design Guide Update 298594-005, dated March 2002. Figure 100 has two additional changes in the ICH2 section.

- 1. An ICH2 power plane is added to it. This added ICH2 power plane is "ICH2 CMOS". This power plane has always existed in the ICH2. It is not new. This addition to the Power Delivery Map simply shows this ICH2 plane.
- 2. An ICH2 power plane is added to it. This added ICH2 power plane is "ICH2 Resume 1.8 VSB". This power plane has always existed in the ICH2. It is not new. This addition to the Power Delivery Map simply shows this ICH2 plane.

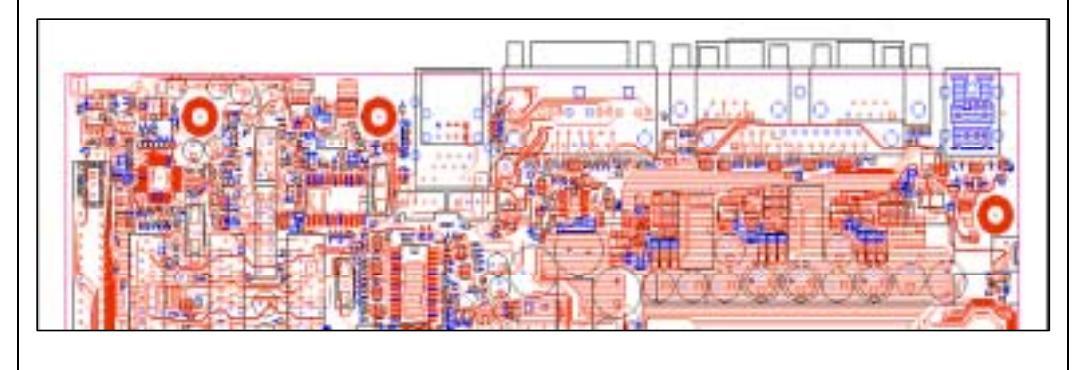
Figure 1. Top Signal Layer before the Ground Fill near the I/O Layer

Electrostatic discharge (ESD) into a system can lead to system instability, and possibly cause functional failures when a system is in use. There are system level design methodologies that when followed can lead to higher ESD immunity. Electromagnetic fields due to ESD are introduced into a system through chassis openings such as the I/O back panel and PCI slots. These fields can introduce noise into signals and cause the system to malfunction. One can reduce the potential for

issues at the I/O area by adding more ground plane on the motherboard around the I/O area. This can lead to a higher ESD immunity.

Intel recommends that the I/O area on the top and bottom signal layers of a 4-layer motherboard near the I/O back panel be filled with a ground fill as shown in Figures 1-4. In addition, a ground fill cutout should be placed on the Vcc layer in the area where the ground fill is done on the top and bottom layers. Intel recommends filling the I/O area as much as possible without effecting the signal routing. The board designer should fill the entire I/O area along the board edge.

The spacing from the ground fill to other shapes/traces should be at least 20 mils. It is recommended that these ground fill areas be connected to two chassis mounting holes (as seen in Figure 2). This will allow ESD current to travel to the chassis instead of the board. Ground stitching vias should be placed throughout the entire ground fill if possible. It is important that the vias are placed along the board edge. Ground stitching vias for the ground fill should be 100-150 mils apart or less.

- 1. Fill the I/O area with the ground fill in all layers including signal layers whenever possible
- 2. Extend the ground fill along the entire back I/O area
- 3. Connect the ground fill to mounting holes
- 4. Place stitching vias 100-150 mils apart in the entire ground fill
